Mar 23rd, 2026

XXXXXXXXXX, XXXXXXXX, GA 31015

Home Inspection Report

James Register / True Core Home Inspections, LLC

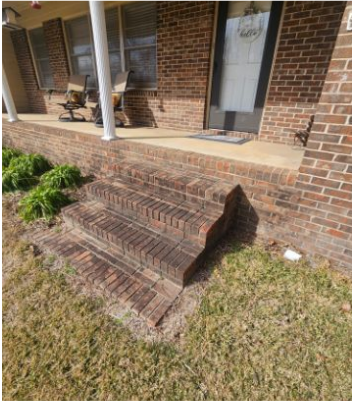
Location - Front door entrance steps

Missing Handrail

A handrail is missing at the front entry steps. This condition increases the risk of falls. Recommend installation of a secure handrail.

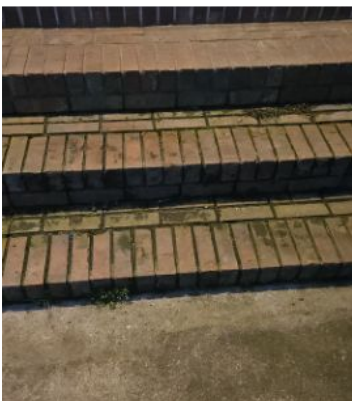
Organic Growth

Organic growth was observed on the rear entrance steps, which may create a slip hazard. Recommend cleaning and treating the surface to improve traction.

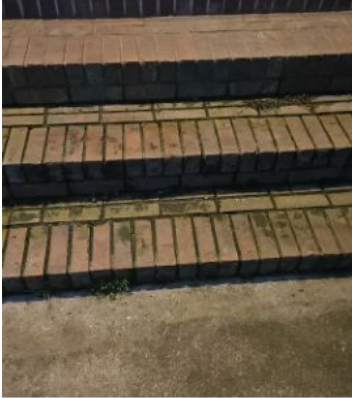
Location - Back door

Rear entrance steps

A handrail is missing at the rear entrance steps. This condition increases the risk of falls. Recommend installation of a secure handrail.

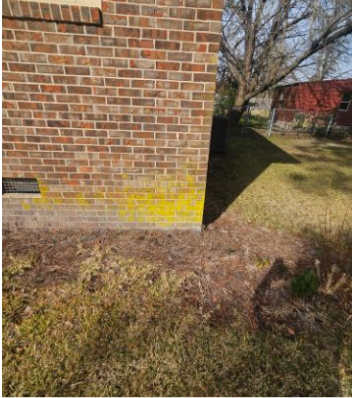
Algae/Moss Growth on Exterior Brick Wall

Brick exterior was generally in good condition at the time of inspection. One localized area of organic growth (such as algae or moss) was observed, which may indicate prolonged moisture exposure. Recommend cleaning the affected area using appropriate methods and monitoring for recurrence. If growth persists, further evaluation may be needed to identify and address underlying moisture sources.

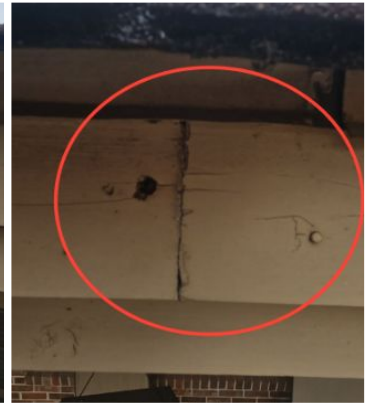
Exposed nail and wood

Exposed nail heads and areas of wood deterioration were observed on the exterior. These conditions can allow moisture intrusion and lead to further deterioration over time. Recommend sealing or replacing affected wood and properly securing or covering exposed nails to help protect against weather damage. A qualified contractor should evaluate and address repairs as needed.

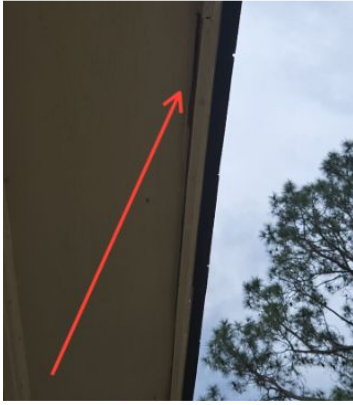
Exposed nail and wood. Seam needs to be sealed

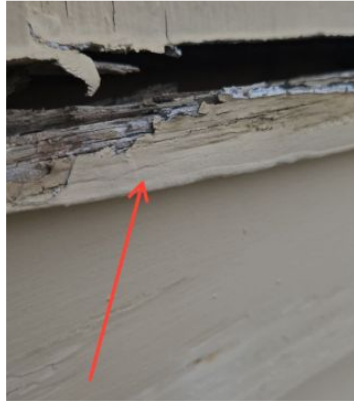
Gap between soffit and fascia

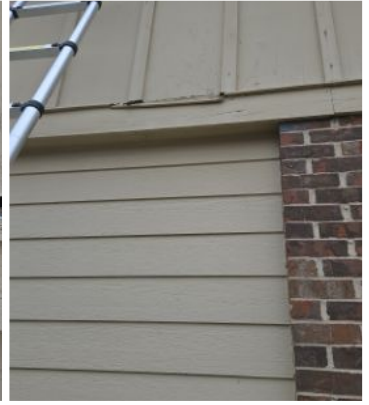
Close-up of rotten wood

Rotten wood

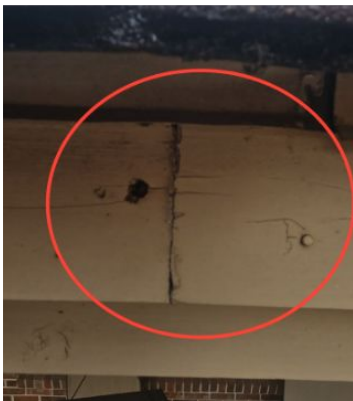
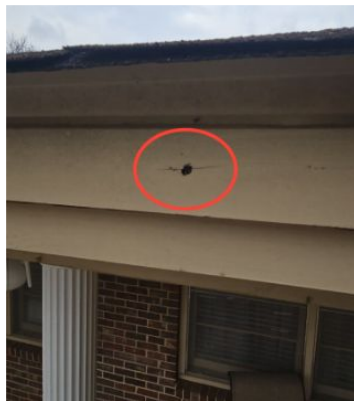
Location - South side above front porch

Rotten wood

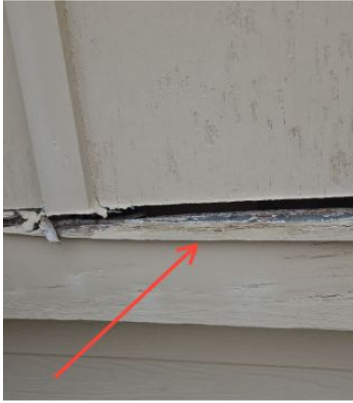
Location - West side of house

Soffit/Fascia Rot or Damage

Deterioration was observed at the soffit and/or fascia. Recommend repair or replacement of affected areas to prevent further damage.

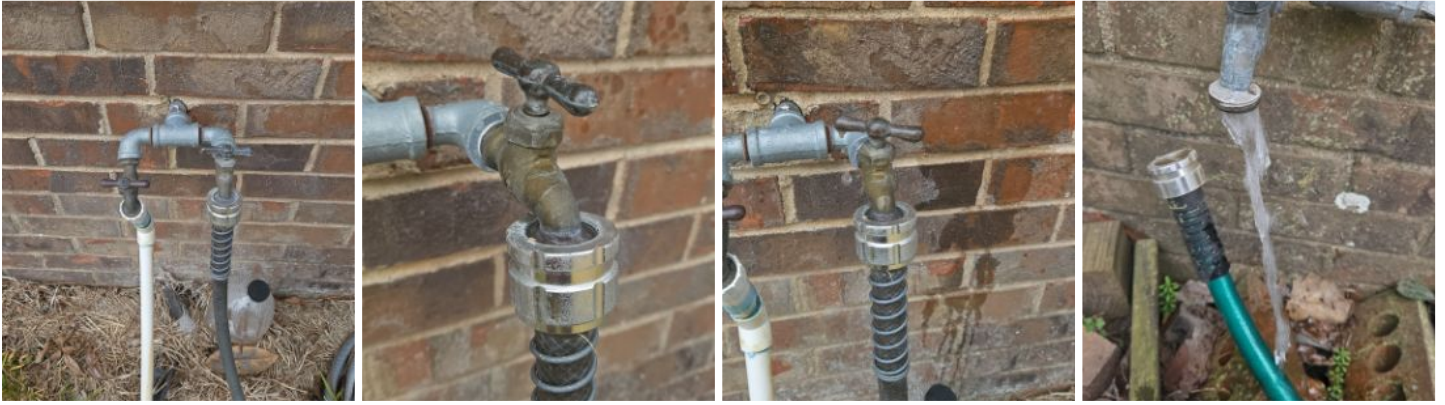
Spigots Missing Anti-siphon device
Missing anti-siphon device

Exterior hose spigots were observed without anti-siphon (backflow prevention) devices. This safety feature helps prevent contaminated water from being drawn back into the home's potable water system. Recommend installing anti-siphon devices or frost-free hose bibs with built-in protection to improve safety. A qualified plumber can complete this upgrade quickly and affordably.

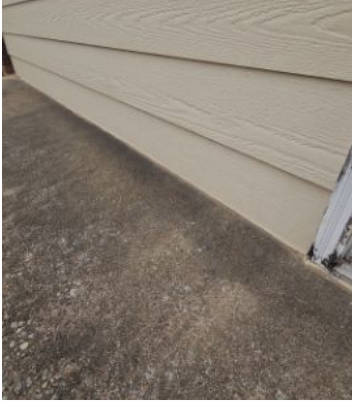
Location - Southwest corner. Closed-in carport

Some areas of siding are in direct contact with the ground or concrete. This condition is common in older homes and can contribute to moisture exposure and accelerated wear over time. Consider adjusting or trimming siding to maintain proper clearance from the ground, which can help reduce the risk of moisture-related damage.

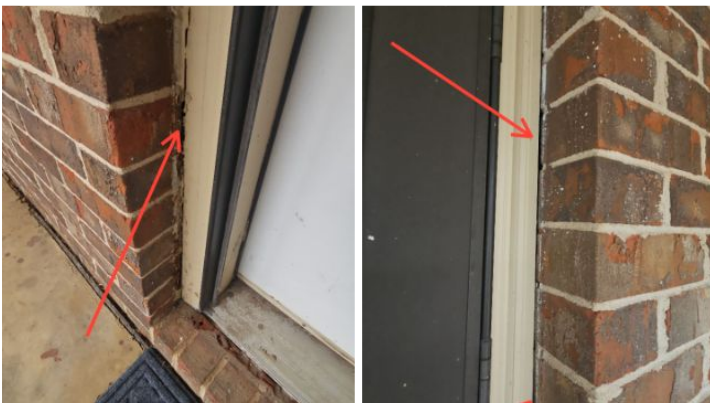
Location - Front Porch

Missing Sealant

Sealant is missing at sections of the brick mold. Although this area is not directly exposed to rain, gaps can still allow air intrusion and potential moisture entry over time. Recommend applying an appropriate exterior-grade sealant to all gaps to improve the building envelope and help prevent future deterioration. Periodic monitoring is advised.

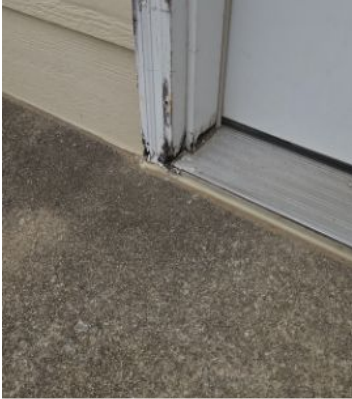
Location - Side door leading into enclosed carport

Some wood at the brick molding around the side door shows minor rot. This is typical in older homes and can be addressed with routine maintenance. Repair or replace affected sections as part of general upkeep to prevent further deterioration.

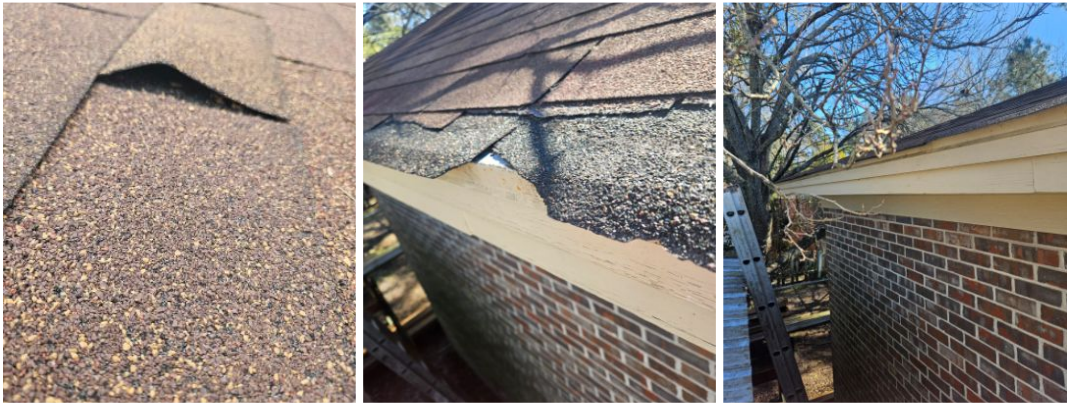
Location - South Facing Roof

Roof shingles show localized damage, including several torn areas likely caused by contact with a nearby tree limb, along with a few visible nail pops. These conditions can allow moisture intrusion over time. The roof is estimated to have approximately 5 years of remaining service life. Recommend trimming back overhanging branches to prevent further damage and having a qualified roofing contractor repair or replace damaged shingles and address nail pops to maintain proper performance. Regular monitoring is advised.

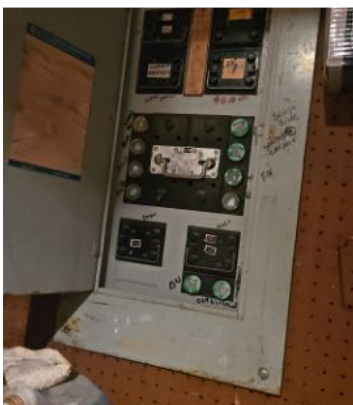
Fuse style service panel

The home is equipped with a fuse-style electrical panel. While functional, this is an older system. Recommend evaluation and upgrades as needed.

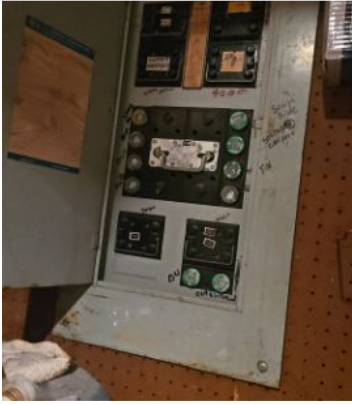
Electrical Panel - Circuit Labeling

Circuit labeling at the electrical panel is incomplete or unclear. Recommend properly identifying and labeling circuits for ease of use.

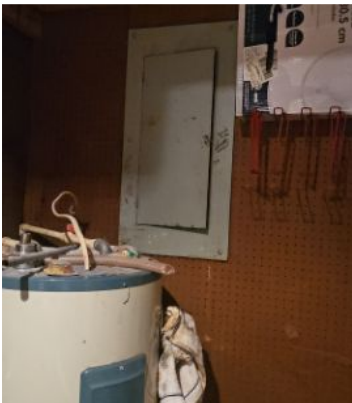
Location - Utility Room

Access to the electrical panel is obstructed. This condition can delay emergency shutoff. Recommend providing clear, unobstructed access to the panel.

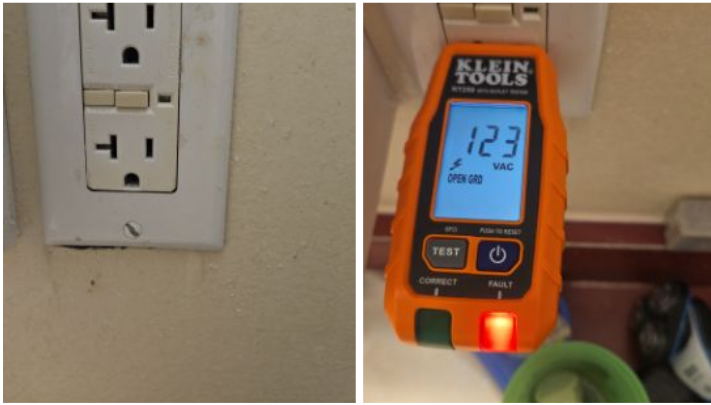
GFCI Protection Missing

GFCI protection was not observed at outlets in areas where it is typically recommended (kitchen, bath, exterior, garage, laundry).

This is a common condition in older homes and may have been acceptable at the time of construction.

Upgrading to GFCI protection is recommended for improved safety.

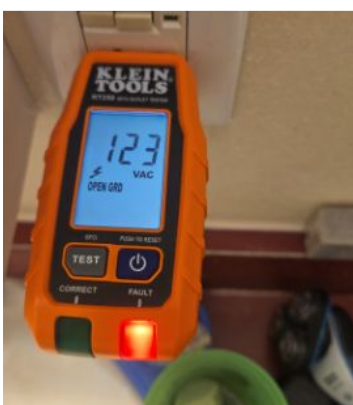
Open Ground - Receptacle

One or more receptacles tested as open ground. This condition may reduce effectiveness of surge protection and presents a potential safety concern. Recommend evaluation and correction by a qualified electrician.

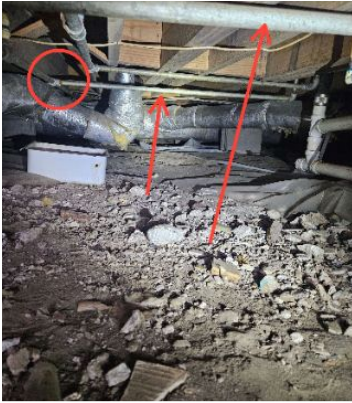
Location - Crawlspace

The home has galvanized water supply lines. Galvanized piping is common in older homes but may be prone to internal corrosion over time, which can reduce water flow and increase the risk of leaks.

Routine monitoring of water pressure and flow is recommended. Consider consulting a licensed plumber for evaluation or planning for eventual replacement as part of long-term maintenance.

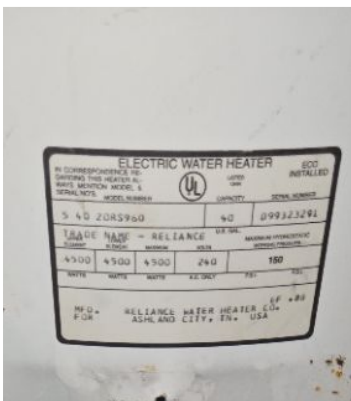
Water Heater

The water heater (Reliance, 40-gallon) was manufactured in 1996 and is beyond its typical service life. Unit may be prone to failure. Recommend budgeting for replacement.

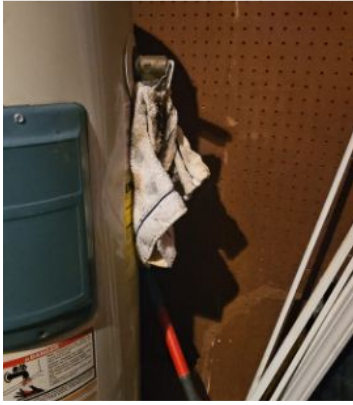
Water Heater - Missing TPR Discharge Pipe

A temperature and pressure relief (TPR) discharge pipe was not observed at the water heater. This condition can allow hot water or steam to discharge improperly. There are also signs of active leaking from the TPR valve. Recommend installation of a proper discharge pipe.

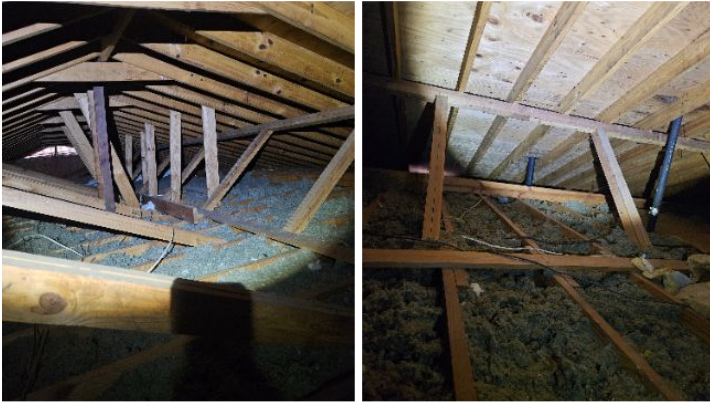
Location - Attic

The attic is insulated with blown-in fiberglass, which measures less than 6 inches in depth. This is less than current recommended levels for energy efficiency.

Recommendation: Adding insulation is recommended to improve energy efficiency and help maintain more consistent indoor temperatures.

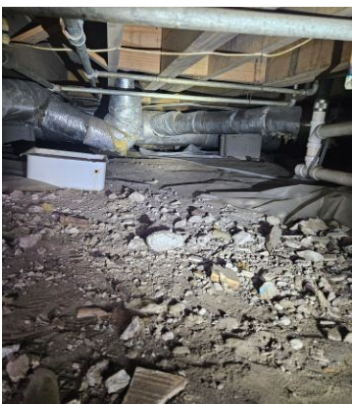
Location - Crawlspace

The crawlspace vapor barrier is significantly incomplete or displaced, with large areas of exposed soil observed. This condition can allow excessive moisture into the crawlspace. Recommend repair or replacement.

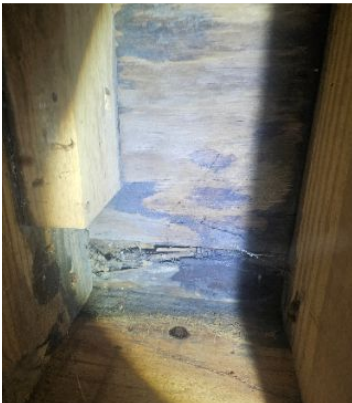
Wood Rot - Crawlspace Structural Components

Fungal decay (wood rot) was observed at floor joists, rim joist, sill plate, and subfloor in the crawlspace. Deterioration and material loss were noted. Recommend evaluation and repair by a qualified contractor.

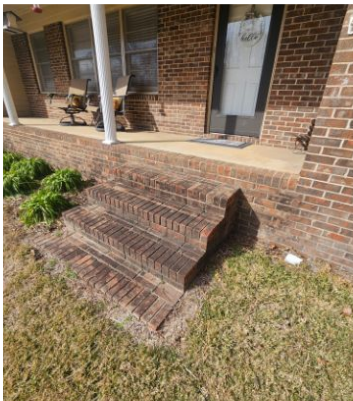
Location - Front door entrance steps

A handrail is missing at the front entry steps. This condition increases the risk of falls. Recommend installation of a secure handrail.

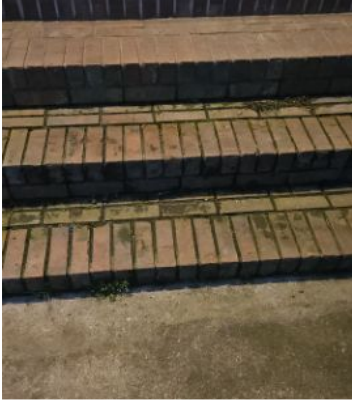
Organic Growth

Organic growth was observed on the rear entrance steps, which may create a slip hazard. Recommend cleaning and treating the surface to improve traction.

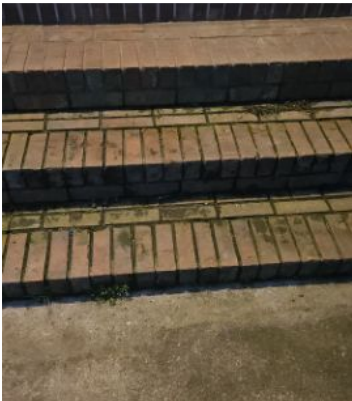
Location - Back door

Rear entrance steps

A handrail is missing at the rear entrance steps. This condition increases the risk of falls. Recommend installation of a secure handrail.

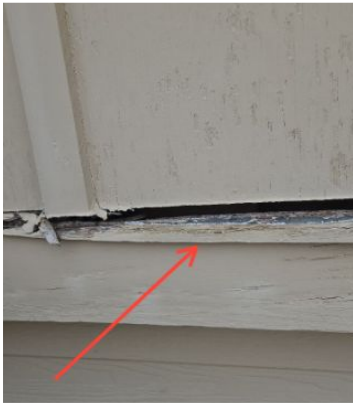
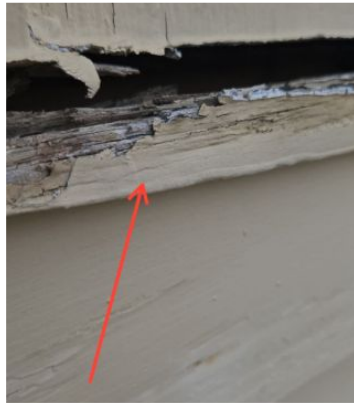
Location - West side of house

Deterioration was observed at the soffit and/or fascia. Recommend repair or replacement of affected areas to prevent further damage.

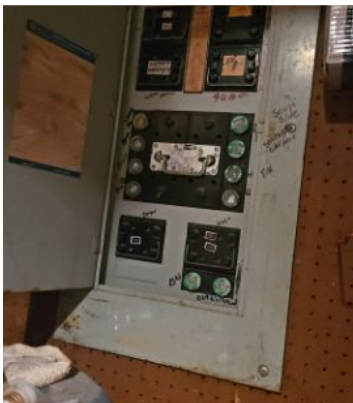
Fuse style service panel

The home is equipped with a fuse-style electrical panel. While functional, this is an older system. Recommend evaluation and upgrades as needed.

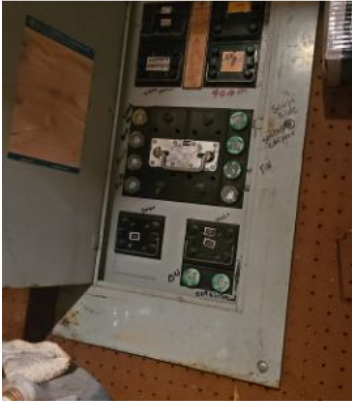
Electrical Panel - Circuit Labeling

Circuit labeling at the electrical panel is incomplete or unclear. Recommend properly identifying and labeling circuits for ease of use.

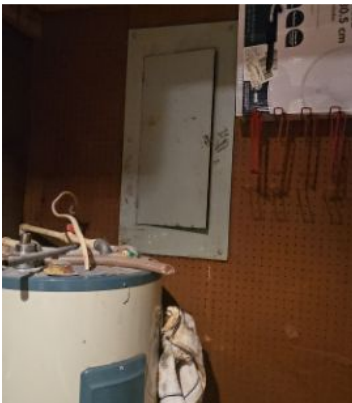
Location - Utility Room

Access to the electrical panel is obstructed. This condition can delay emergency shutoff. Recommend providing clear, unobstructed access to the panel.

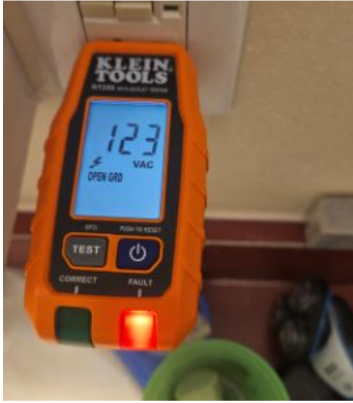
Open Ground - Receptacle

One or more receptacles tested as open ground. This condition may reduce effectiveness of surge protection and presents a potential safety concern. Recommend evaluation and correction by a qualified electrician.

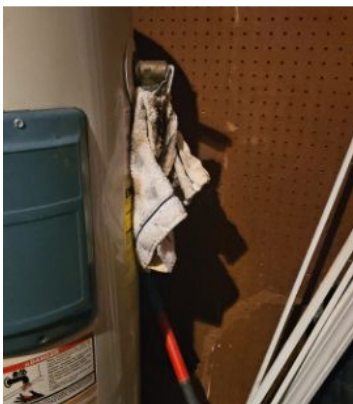
Water Heater - Missing TPR Discharge Pipe

A temperature and pressure relief (TPR) discharge pipe was not observed at the water heater. This condition can allow hot water or steam to discharge improperly. There are also signs of active leaking from the TPR valve. Recommend installation of a proper discharge pipe.

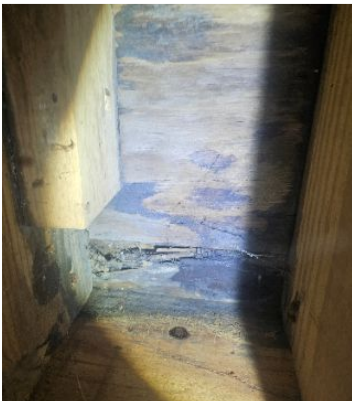
Wood Rot - Crawlspace Structural Components

Fungal decay (wood rot) was observed at floor joists, rim joist, sill plate, and subfloor in the crawlspace. Deterioration and material loss were noted. Recommend evaluation and repair by a qualified contractor.
