Mar 23rd, 2026

XXXXXXXXXX, XXXXXXXX, GA 31015

Home Inspection Report

James Register / True Core Home Inspections, LLC

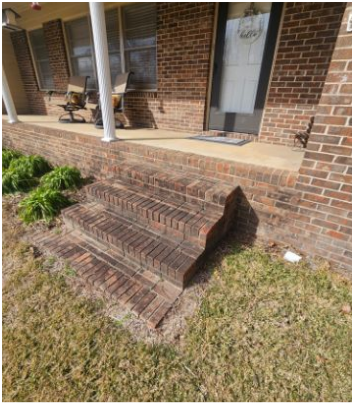
1.2 STEPS/STOOPS

Missing Handrail

A handrail is missing at the front entry steps. This condition increases the risk of falls. Recommend installation of a secure handrail.

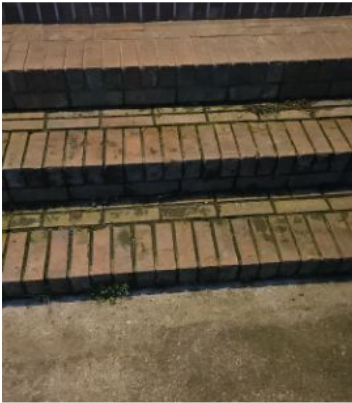
LOCATION: Back door entrance

Organic growth was observed on the rear entrance steps, which may create a slip hazard. Recommend cleaning and treating the surface to improve traction.

A handrail is missing at the rear entrance steps. This condition increases the risk of falls. Recommend installation of a secure handrail.

Recommend that a qualified contractor evaluate and estimate cleaning

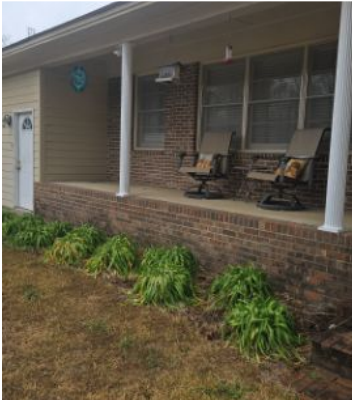
Location - Front of house

The front porch was inspected and found to be in good condition at the time of inspection. The floor surfaces, support structure, and connections to the main dwelling appear structurally sound. No significant settlement, wood rot, or tripping hazards were identified.

Maintenance Recommendation: To maintain the current condition, ensure that the porch remains clear of heavy organic debris and cleaned and resealed periodically to prevent UV and moisture damage.

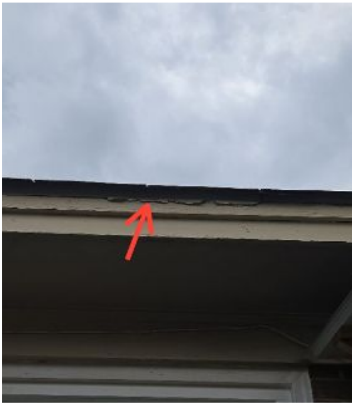
Paint lifted from wood surface from drip edge movement.

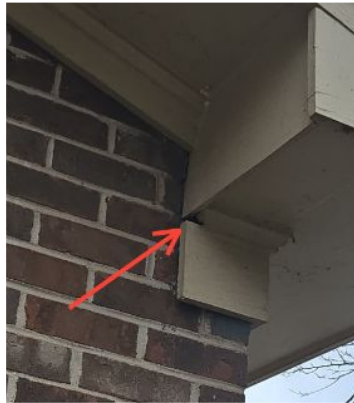
Open access to attic for pests.

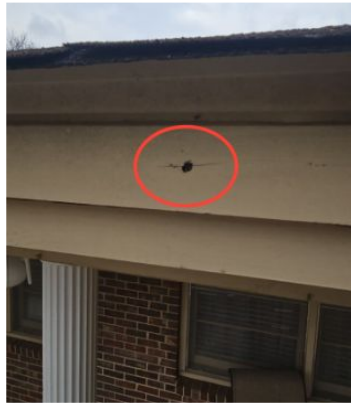
Exposed nail and wood

Exposed nail heads and areas of wood deterioration were observed on the exterior. These conditions can allow moisture intrusion and lead to further deterioration over time. Recommend sealing or replacing affected wood and properly securing or covering exposed nails to help protect against weather damage. A qualified contractor should evaluate and address repairs as needed.

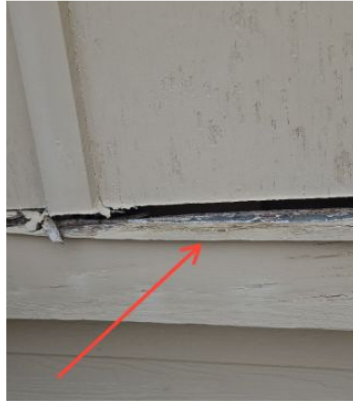
Rotten wood

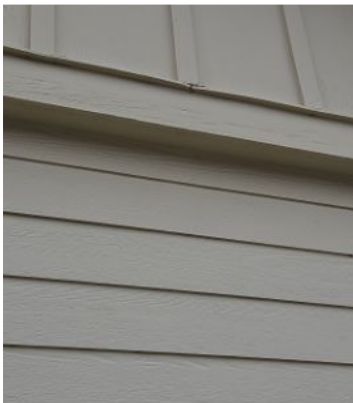
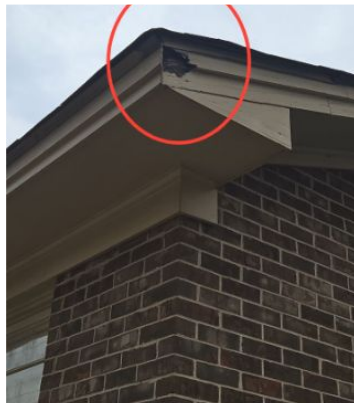
Rotten wood

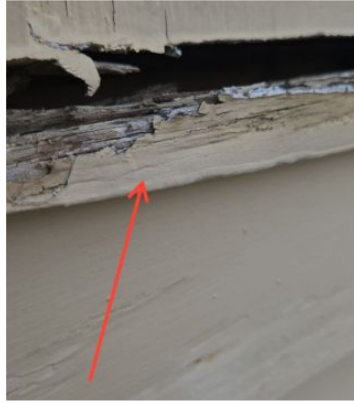
Close-up

Soffit/Fascia Rot or Damage

Deterioration was observed at the soffit and/or fascia. Recommend repair or replacement of affected areas to prevent further damage.

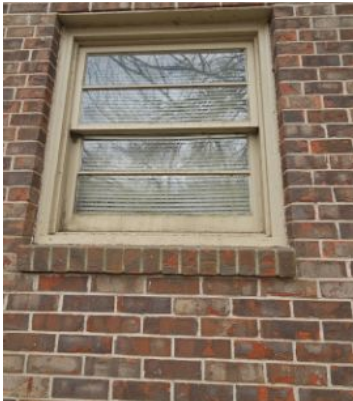
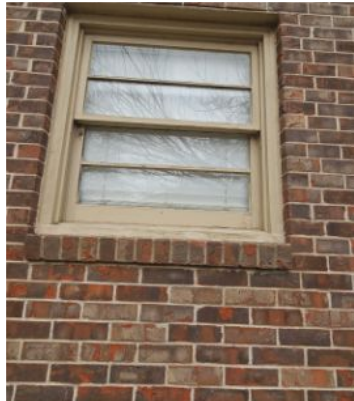
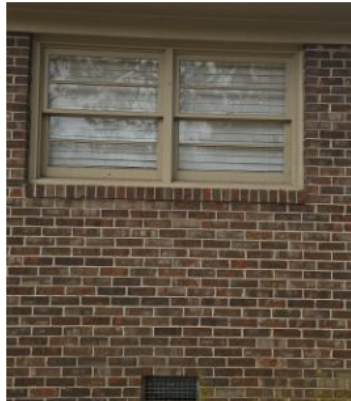
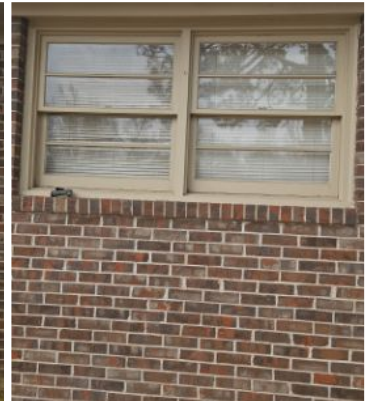
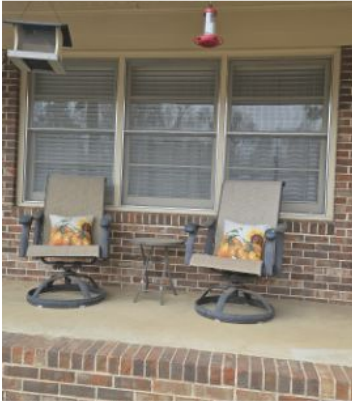
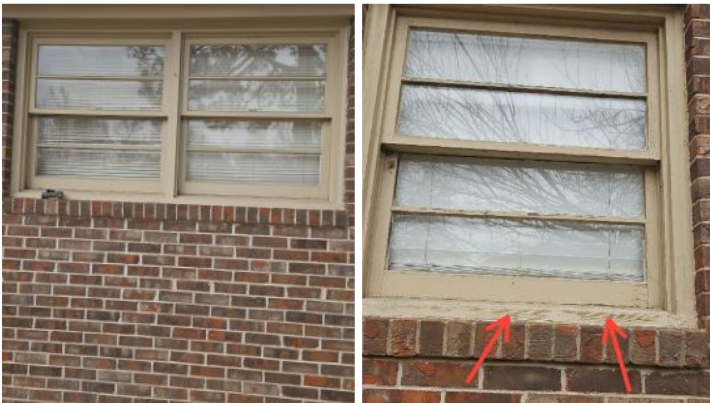
Location - Most windows throughout the house

Some windows were noted to be a bit tight during operation, which is common with normal use and age. Windows were operable at the time of inspection.

Minor adjustment or maintenance may improve ease of use, as desired.

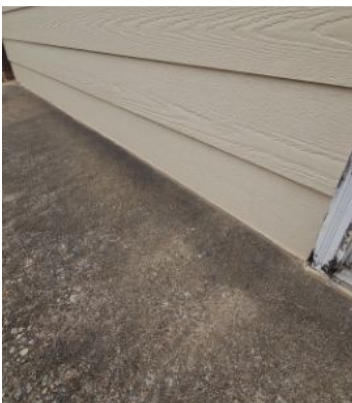
LOCATION: Southwest corner of house. Closed in carport.

Some areas of siding are in direct contact with the ground or concrete. This condition is common in older homes and can contribute to moisture exposure and accelerated wear over time. Consider adjusting or trimming siding to maintain proper clearance from the ground, which can help reduce the risk of moisture-related damage.

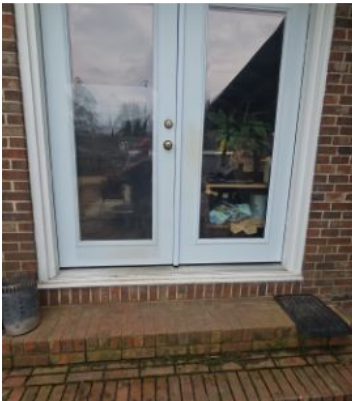
LOCATION: Patio door

According to the current homeowner, the patio door has been replaced within the past 12 months. All wood was replaced with PVC wood. The door was in good working order at the time of the inspection

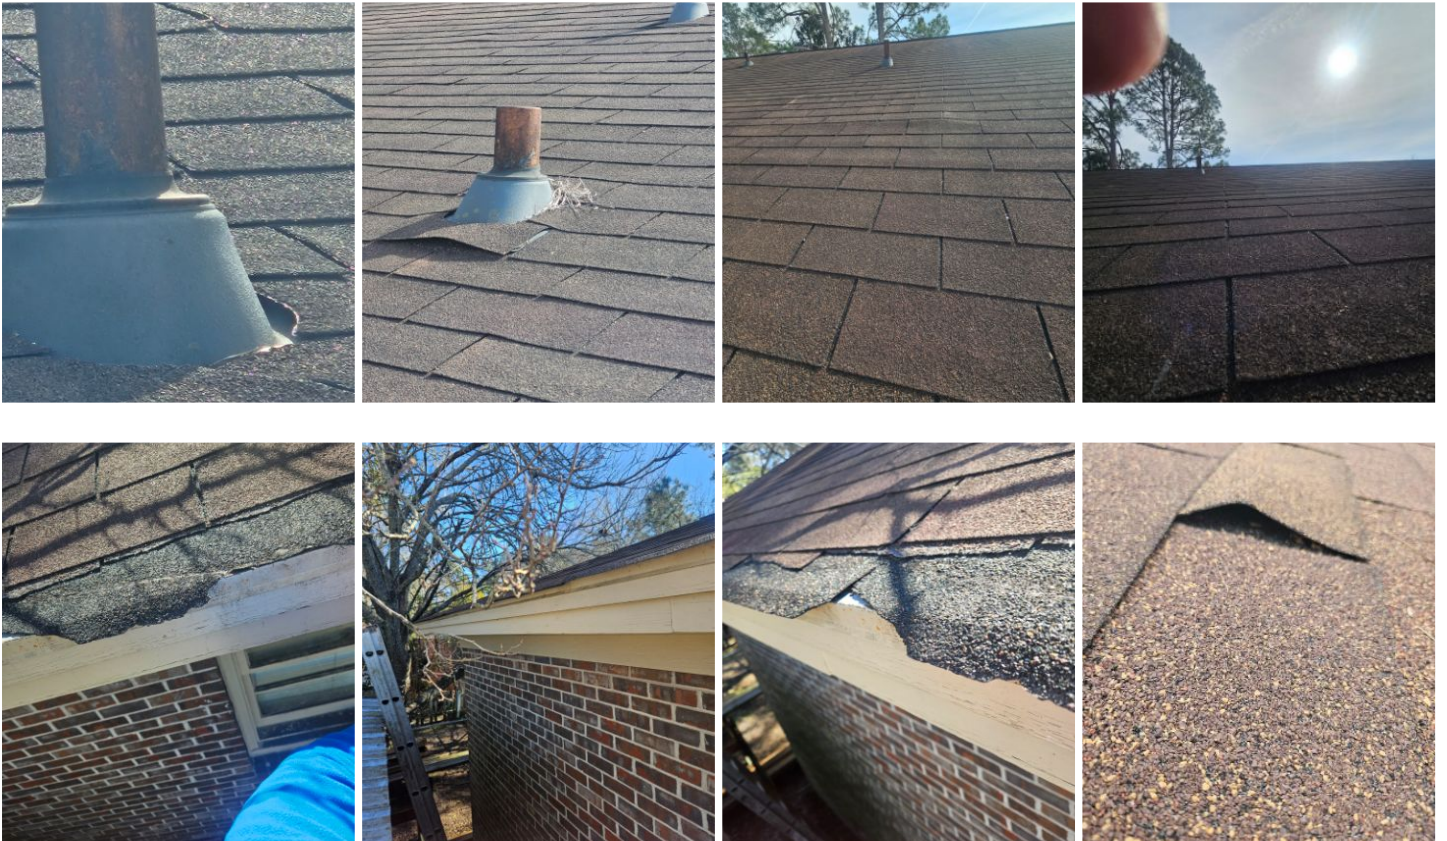
Roof shingles show localized damage, including several torn areas likely caused by contact with a nearby tree limb, along with a few visible nail pops. These conditions can allow moisture intrusion over time. The roof is estimated to have approximately 5 years of remaining service life. Recommend trimming back overhanging branches to prevent further damage and having a qualified roofing contractor repair or replace damaged shingles and address nail pops to maintain proper performance. Regular monitoring is advised.

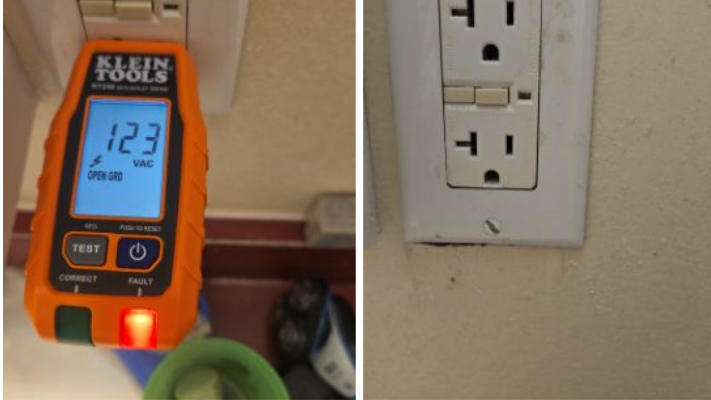
LOCATION: Outlet is located adjacent to the sink.

See comments and recommendations in Electrical section

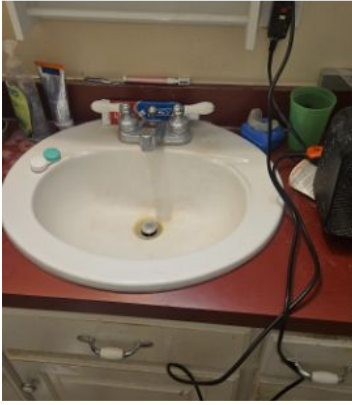
Location - Bathroom 1

The bathroom countertop and sink were inspected and appear to be in good condition. No visible damage or functional issues were observed at the time of inspection.

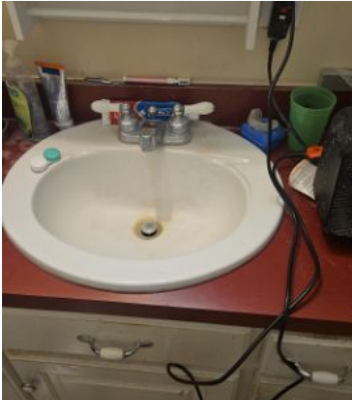
The sink was operated during the inspection and performed as intended at the time of evaluation. Water flow, hot and cold temperature response, and drainage were observed to be in good working order with no visible leaks or deficiencies noted. Routine maintenance and monitoring are recommended.

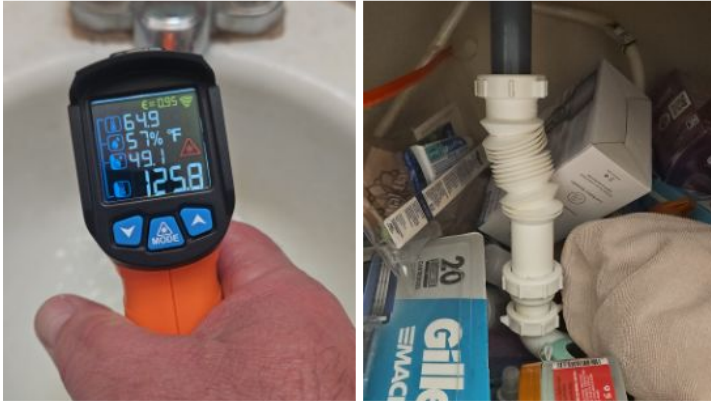
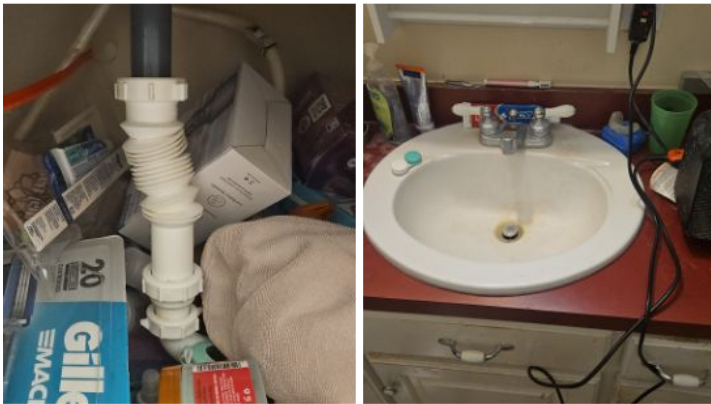
Location - Bathroom 1

Water pressure in the bathroom was tested and found to be good. Hot water temperature measured approximately 126°F, which is within a normal and safe operating range for household use.

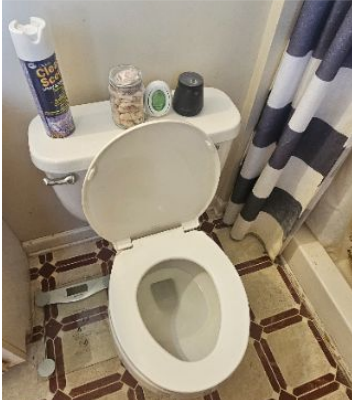
Toilet is functional and properly secured to the floor. The tank and bowl are free of cracks, and the water level is set correctly.

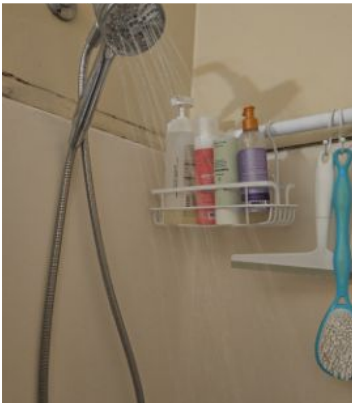
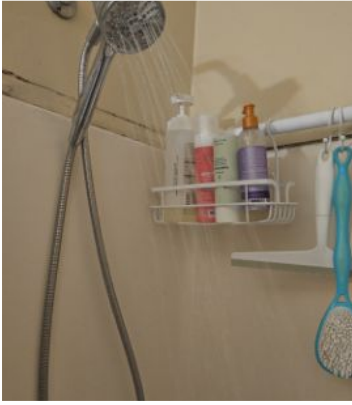
Location - Bathroom 1

The shower was operated during the inspection and responded as intended at the time of evaluation. Water flow, temperature control, and drainage were observed to be in good working order with no visible leaks or deficiencies noted. Routine maintenance and monitoring are recommended.

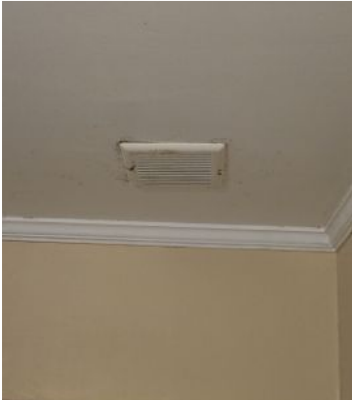
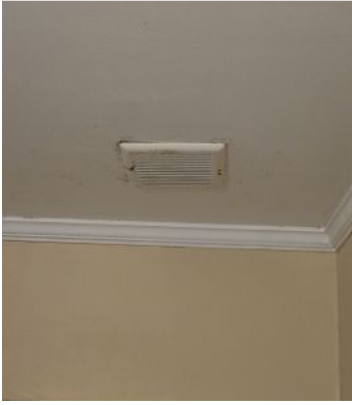
Location - Bathroom 1

The bathroom vent fan was operated during the inspection and responded as intended at the time of evaluation. The fan activated properly and appeared to adequately exhaust air with no unusual noise or deficiencies observed. Routine maintenance and periodic cleaning are recommended.

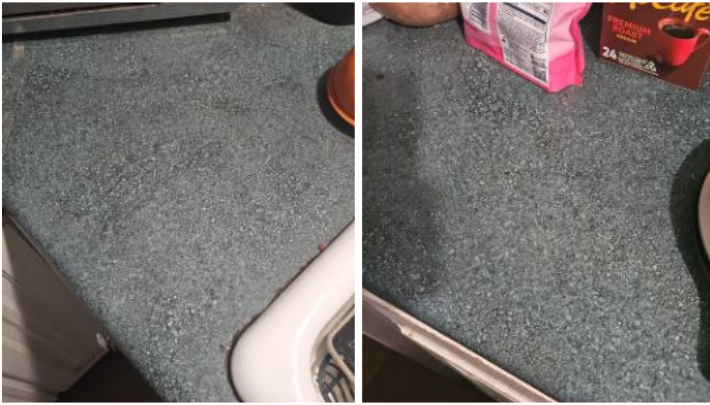
At the time of inspection, the kitchen countertop appears to be in generally good condition with no significant damage visible. However, there are minor scratches and signs of wear that are typical with regular use. No cracks or chips were observed at the time of inspection.

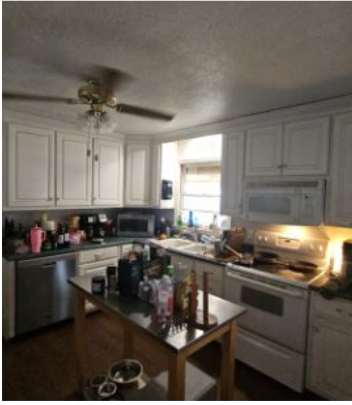
Kitchen cabinets show typical wear consistent with age and use. A few hinges were noted to be loose, which may affect door alignment and operation. Recommend tightening or adjusting hinges as needed and monitoring for any further wear. Repairs are generally minor and can help improve function and extend the life of the cabinetry.

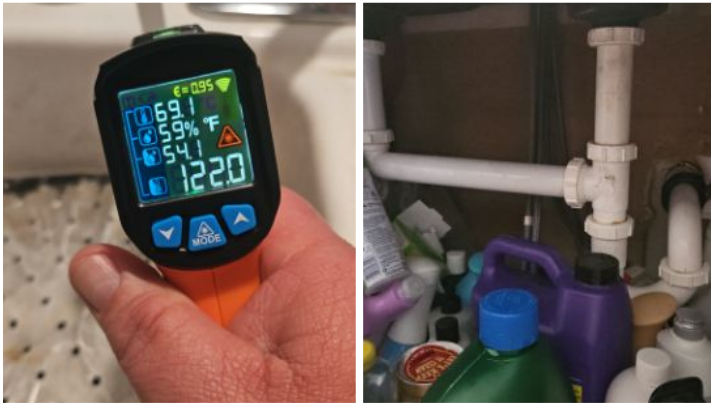
At the time of inspection of the kitchen plumbing, it was observed that the drain lines appear to be in serviceable condition with no visible leaks or signs of significant corrosion. However, some minor buildup is noted around the connections, which could benefit from routine maintenance to ensure optimal drainage and prevent potential blockages. Regular monitoring is advised.

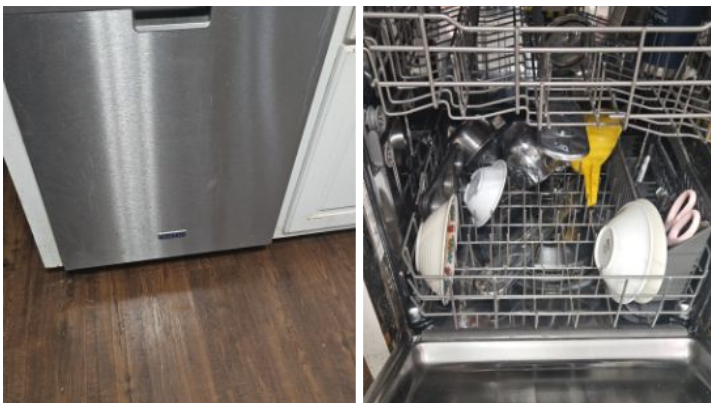
The dishwasher was operated during the inspection and responded as expected. No leaks were observed at the unit, connections, or surrounding area at the time of testing. Overall

condition appeared serviceable. Recommend normal use and routine monitoring for any future leaks or performance issues, and follow manufacturer guidelines for maintenance.

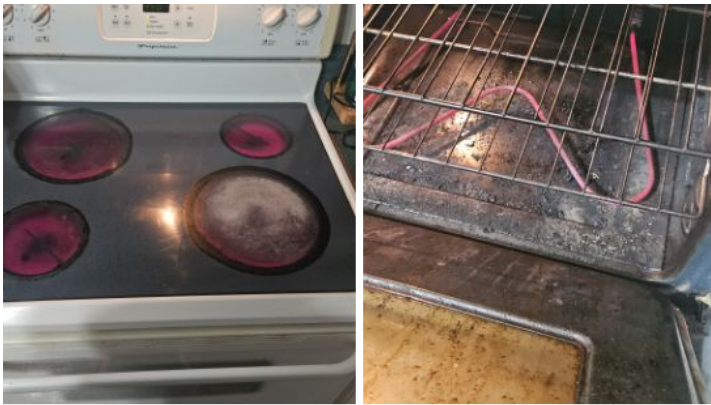
The oven was tested and operated as expected at the time of inspection. However, an anti-tip device was not observed. This safety feature is important to prevent the appliance from tipping forward, which can cause injury or spills. Recommend having a qualified professional install an approved anti-tip bracket in accordance with manufacturer guidelines to improve safety.

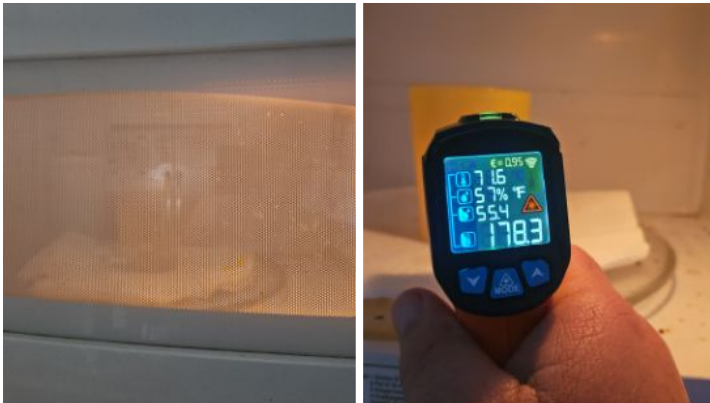
The microwave operated as expected at the time of inspection; however, the door handle was found to be broken. A damaged handle can make the unit difficult to use and may lead to further damage over time. Recommend repair or replacement of the handle to ensure safe and convenient operation.

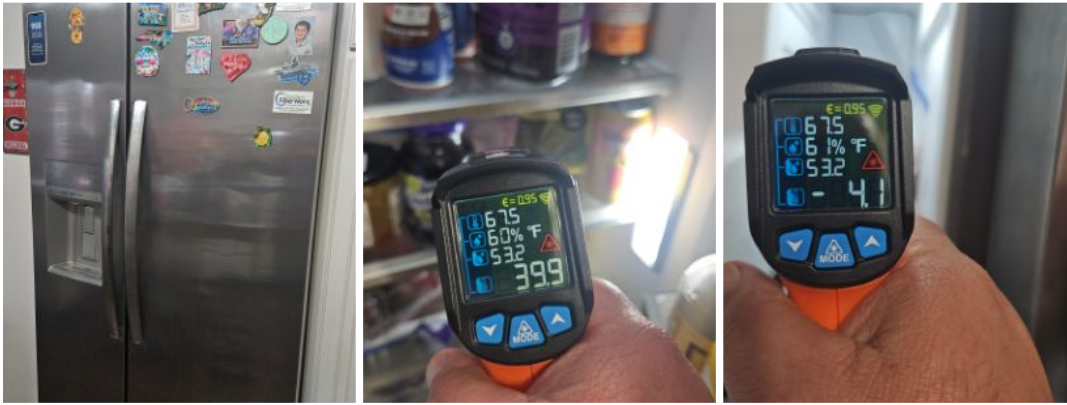
At the time of inspection of the kitchen refrigerator, it was observed that the appliance is functioning as intended with no visible leaks or unusual noises. The interior temperature is maintaining appropriate levels for food safety, and the door seals are intact and in good condition. The water and ice functions properly.

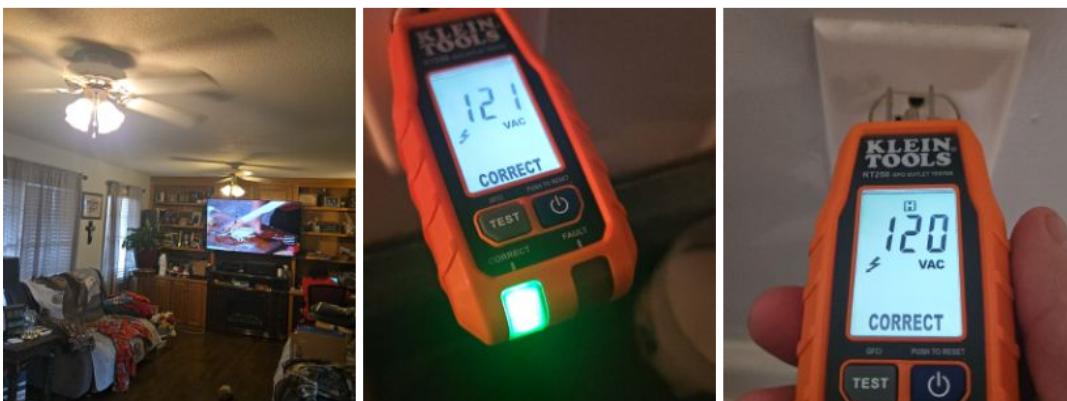
At the time of inspection, a representative number of electrical outlets were tested for grounding and correct polarity. All tested receptacles, along with the wall switches and integrated lighting, were found to be in **good functional condition**.

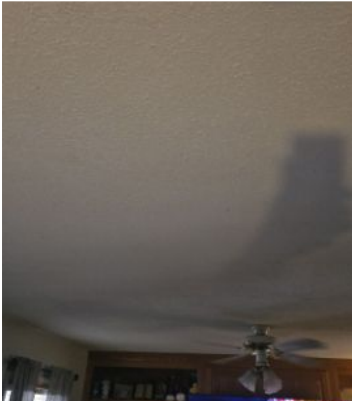
At the time of inspection, the ceiling surfaces appear to be in good condition. No significant cracks, sagging, or evidence of active moisture intrusion were observed.

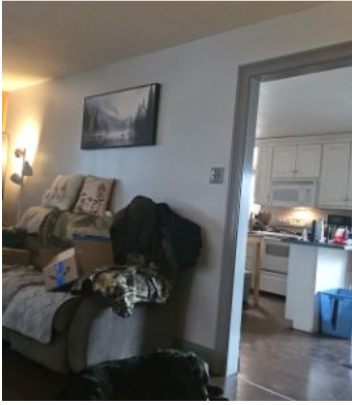
At the time of the inspection, the walls were observed to have minor scuff marks and some small nail holes. There were no signs of major cracks, water damage, or structural issues. Overall, the walls appear to be in good condition with typical wear consistent with regular use.

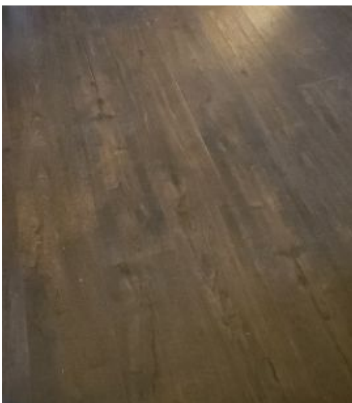
At the time of inspection, the laminate flooring was inspected and found to be in **good condition**. The planks are properly seated with no significant gaps, "buck-

ling," or signs of moisture damage. The surface finish is well-maintained with minimal wear.

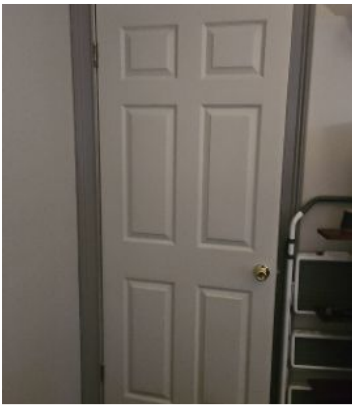
The hollow wood doors in the living area were observed to be functional at the time of inspection. The doors open and close as intended, and the hardware appears to be operational. Typical signs of normal wear were noted, consistent with regular use. No significant deficiencies were observed.
